New Hampshire Volunteer Lake Assessment Program

2002 Bi-Annual Report for Gould Pond Hillsboro

Gould Pond, Hillsboro

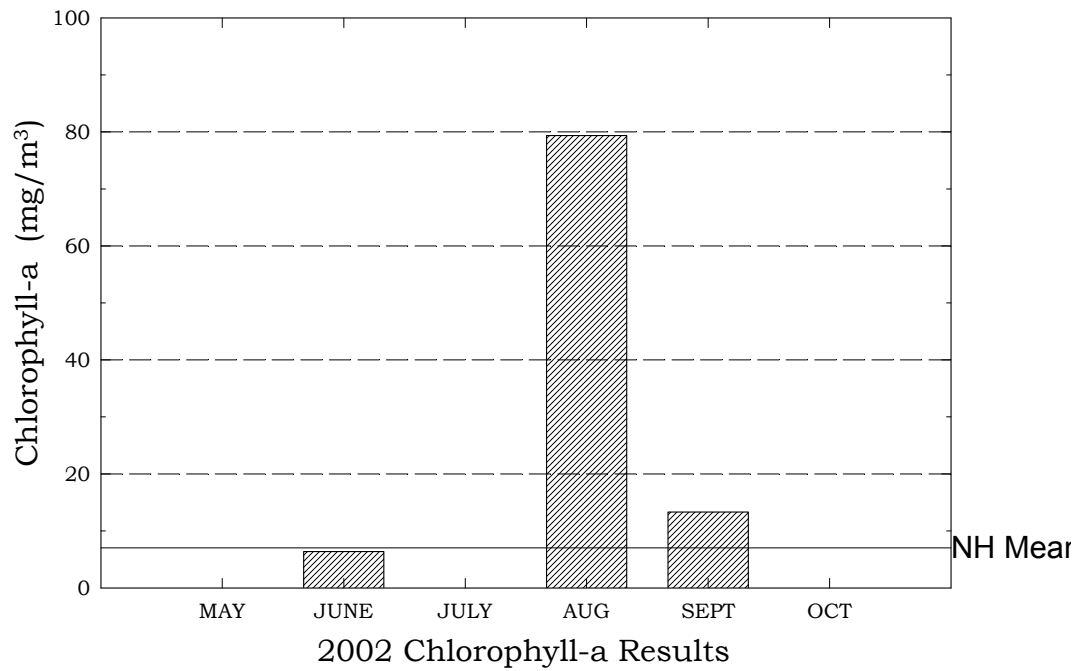
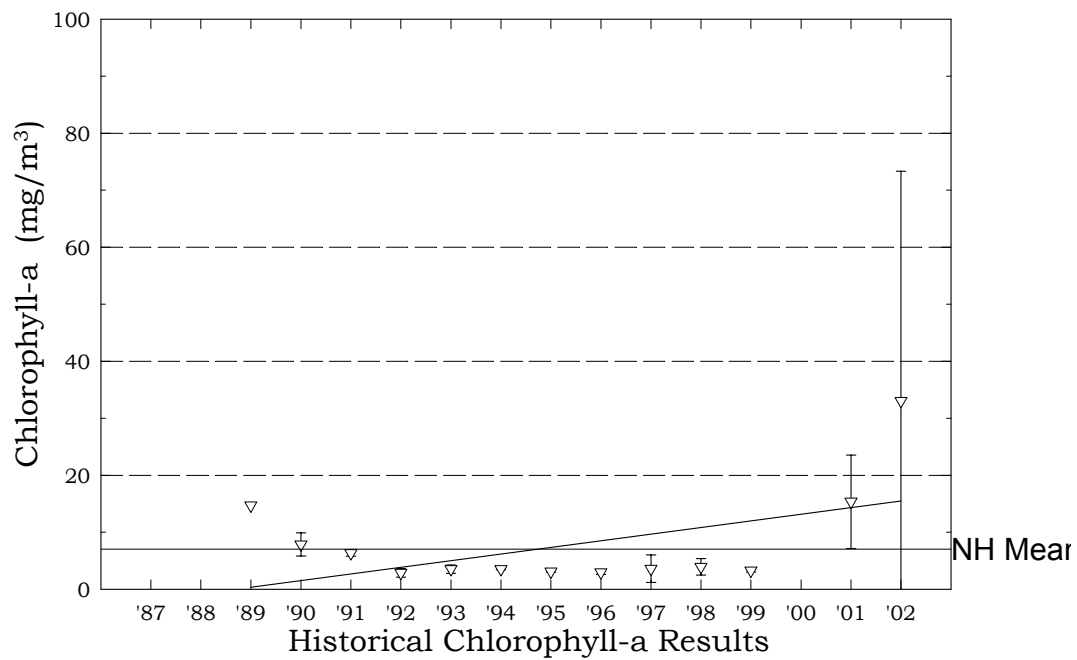
Figure 1. Monthly and Historical Chlorophyll-a Results

- **Figure 1 and Table 1:** The graphs in Figure 1 (Appendix A) show the historical and current year chlorophyll-a concentration in the water column. Table 1 (Appendix B) lists the maximum, minimum, and mean concentration for each sampling season that the lake/pond has been monitored through the program.

The current year data (the top graph) show that the chlorophyll-a concentration **increased greatly** from June to August, and then **decreased greatly** from August to September.

The chlorophyll-a concentration in August was *much greater than* the state mean and is the **greatest** concentration (79.36 mg/m³) that has been observed in the pond since monitoring began. However, this concentration is not consistent with the historic data. The volunteer

monitor (NHDES Biologist Walter Henderson) did note that the pond was “looking pretty green” on the June sampling event. The total phosphorus concentration was not elevated on this sampling event, and a secchi disk reading was not taken. It is likely that the elevated chlorophyll concentration was due to a laboratory error.

The historical data (the bottom graph) show that the 2002 chlorophyll-a mean is ***much greater than*** the state mean.

Overall, visual inspection of the historical data trend line (the bottom graph) shows ***a fluctuating*** in-lake chlorophyll-a trend, meaning that the concentration has ***varied*** since monitoring began in 1989.

While algae are naturally present in all lakes/ponds, an excessive or increasing amount of any type is not welcomed. In freshwater lakes/ponds, phosphorus is the nutrient that algae depend upon for growth. Therefore, algal concentrations may increase when there is an increase in nonpoint sources of nutrient loading from the watershed, or in-lake sources of phosphorus loading (such as phosphorus releases from the sediments). It is important to continually educate residents about how activities within the watershed can affect phosphorus loading and lake quality.

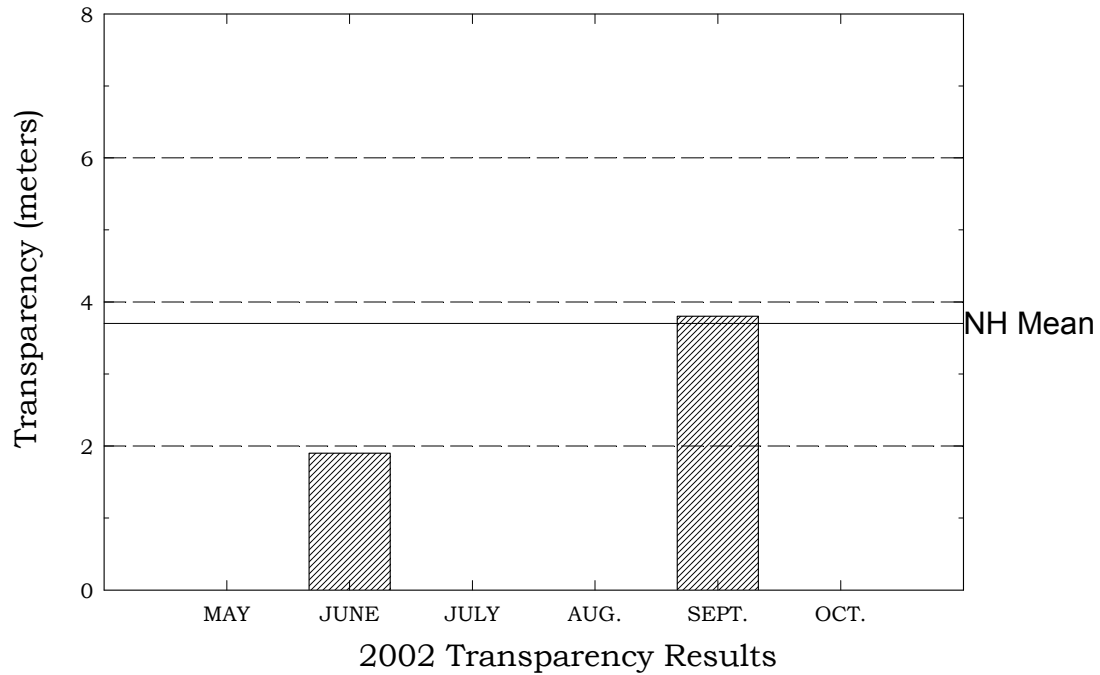
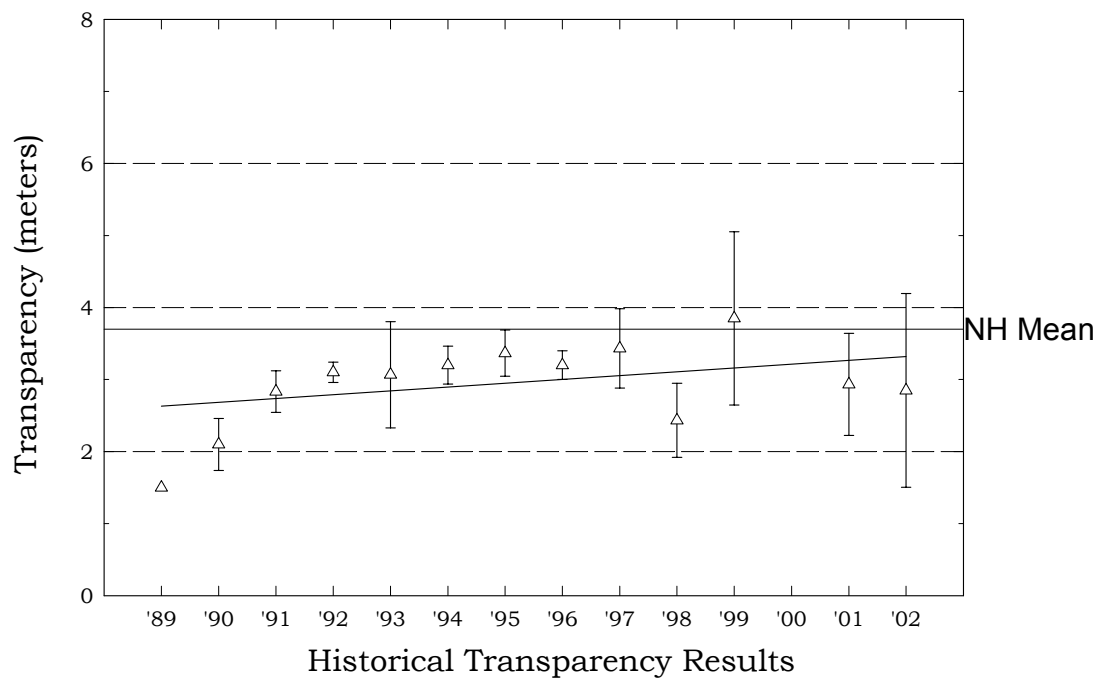
Figure 2. Monthly and Historical Transparency Results

- **Figure 2 and Table 3:** The graphs in Figure 2 (Appendix A) show historical and current year data for lake/pond transparency. Table 3 lists the maximum, minimum and mean transparency data for each sampling season that the lake/pond has been monitored through the program.

The current year data (the top graph) show that the in-lake transparency **increased** from June to September. Please note that a transparency reading was not taken in July because a thunderstorm occurred while sampling and the volunteer monitor had to return to shore.

The historical data (the bottom graph) show that the 2002 mean transparency is **less than** the state mean.

Overall, visual inspection of the historical data trend line (the bottom graph) shows **a slightly increasing** trend for in-lake transparency, meaning that the transparency has **slightly improved** since monitoring began. After 10 consecutive years of sample collection, we will be able to conduct a statistical analysis of the historic data to objectively determine if there has been a significant change in the annual mean transparency since monitoring began.

Typically, high intensity rainfall causes erosion of sediments into lakes/ponds and streams, thus decreasing clarity. Efforts should continually be made to stabilize stream banks, lake/pond shorelines, disturbed soils within the watershed, and especially dirt roads located immediately adjacent to the edge of tributaries and the lake/pond. Guides to Best Management Practices designed to reduce, and possibly even eliminate, nonpoint source pollutants, such as sediment loading, are available from NHDES upon request.

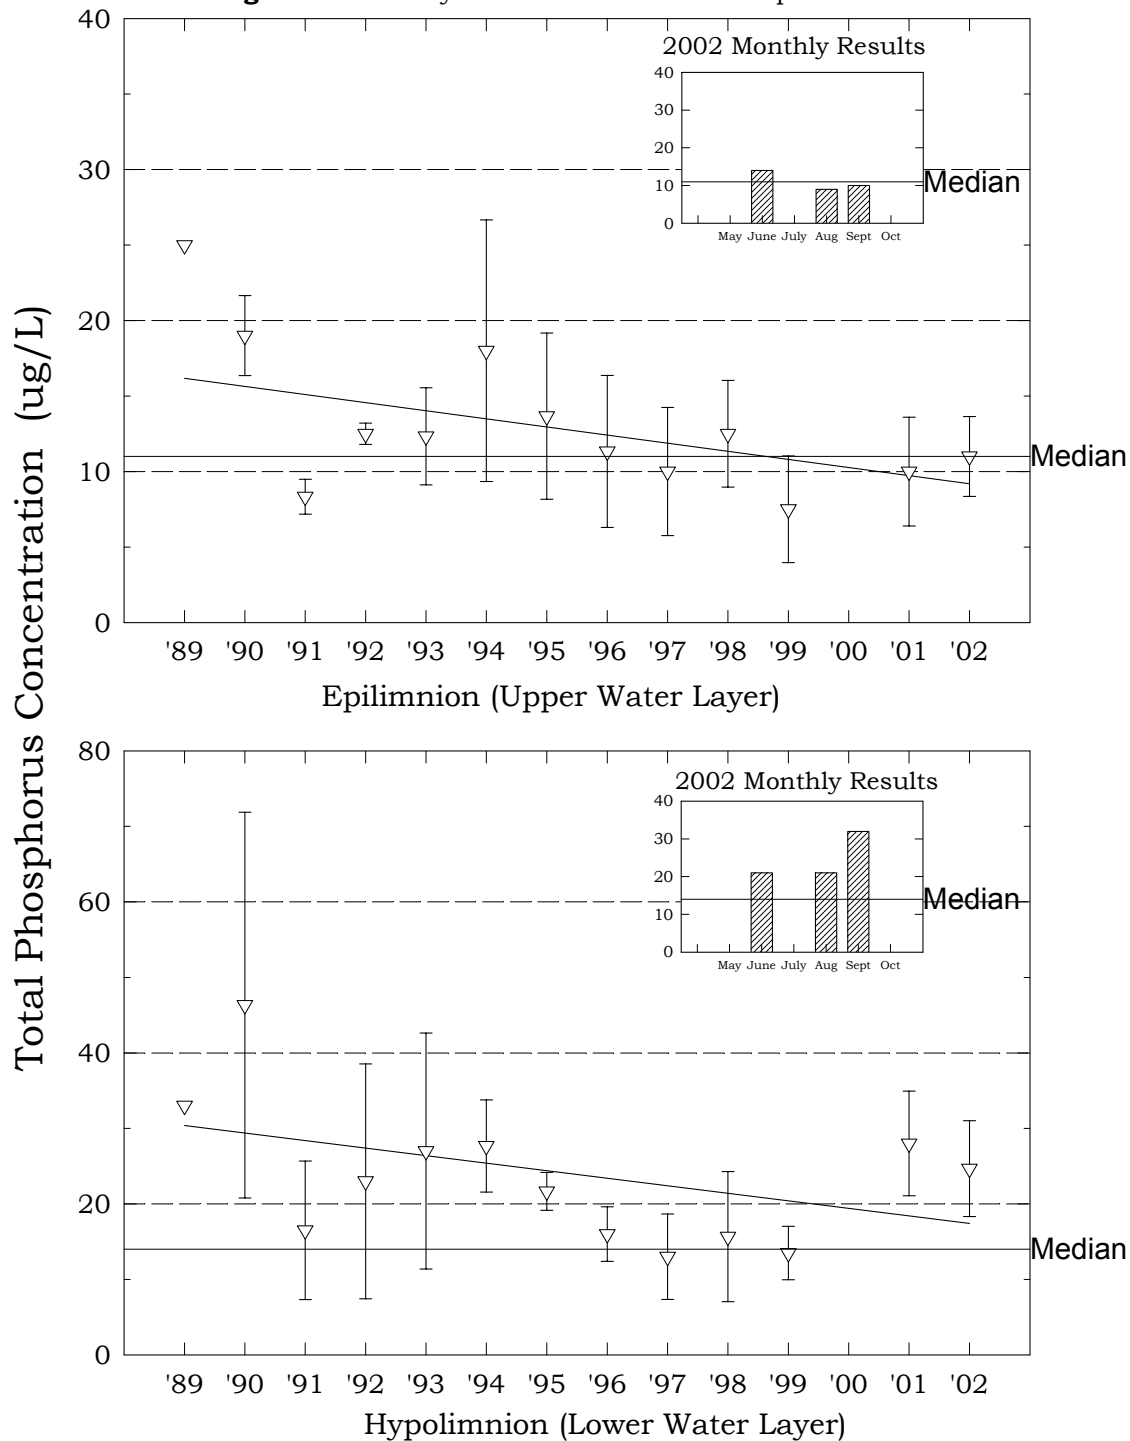
Figure 3. Monthly and Historical Total Phosphorus Data.

- **Figure 3 and Table 8:** The graphs in Figure 3 (Appendix A) show the amounts of phosphorus in the epilimnion (the upper layer) and the hypolimnion (the lower layer); the inset graphs show current year data. Table 8 (Appendix B) lists the annual maximum, minimum, and median concentration for each deep spot layer and each tributary since the lake/pond has joined the program.

The current year data for the epilimnion (the top inset graph) show that the total phosphorus concentration **decreased** from June to August, and then **increased slightly** from August to September.

The historical data show that the 2002 mean epilimnetic total phosphorus concentration is **approximately equal to** the state mean.

The current year data for the hypolimnion (the bottom inset graph) show that the total phosphorus concentration **remained stable** from June to August, and then **increased** from August to September.

The historical data show that the 2002 mean hypolimnetic total phosphorus concentration is **greater than** the state mean.

Overall, visual inspection of the historical data for the epilimnion and the hypolimnion show **a variable** total phosphorus trend, which means that the concentration has **fluctuated** in the pond since monitoring began.

One of the most important approaches to reducing phosphorus loading to a waterbody is to continually educate watershed residents about its sources and how excessive amounts can adversely impact the ecology and value of lakes and ponds. Phosphorus sources within a lake or pond's watershed typically include septic systems, animal waste, lawn fertilizer, road and construction erosion, and natural wetlands. If you would like to educate watershed residents about how they can help to reduce phosphorus loading into the lake/pond, please contact the VLAP Coordinator.
